## ***Phytophthora* Dieback Assessment and Management for:**

### **Armstrong Reserve, Dunsborough**

A report prepared for: Ray Village Aged Services (Inc.) trading as CapeCare and its proposed development of an aged-care facility within part of Armstrong Reserve, Dunsborough, Western Australia

**January 2015**

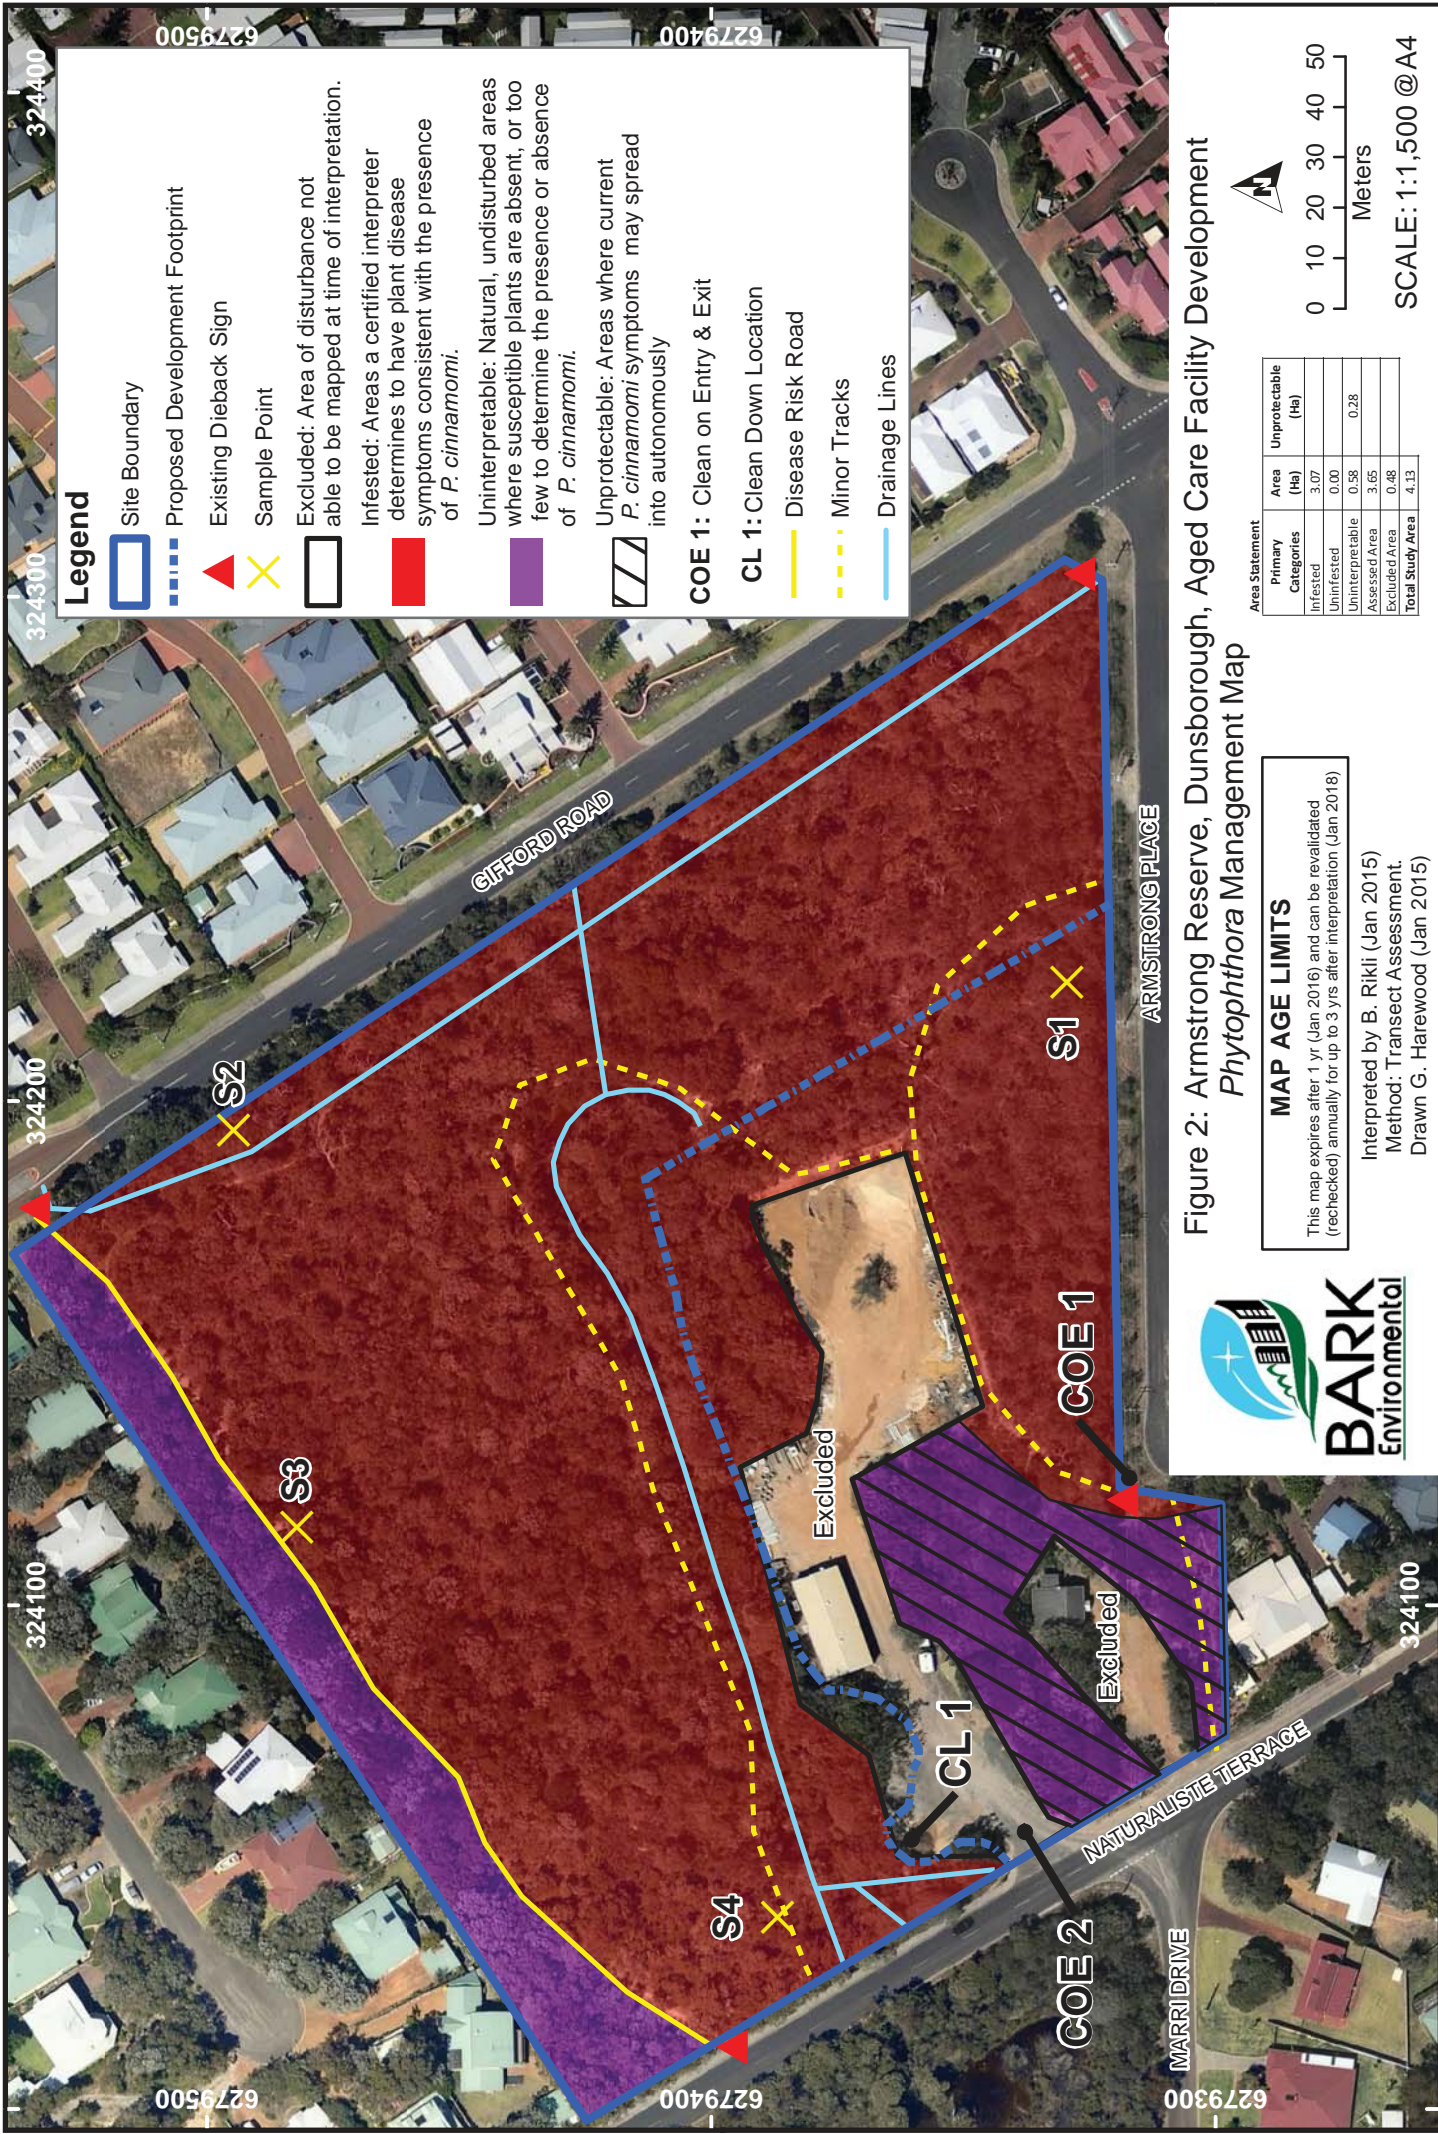
## FIGURE 2

*Phytophthora cinnamomi*  
Management Map

If site operations are necessary during wet-soil conditions, an effective wash-down station could be set-up at the [point marked CL1 on Figure 2. This area is cleared from vegetation and any effluent could easily be channelled into the immediately adjacent and infested open drainage line within the reserve. Avoiding the need for a wash-down station and manage its effluent on site altogether could be achieved by ensuring vehicles, machinery, tools and work boots arrives clean to site and operating in dry-soil conditions only. Brushes and hard tools could be used to clean-down the aforementioned items. If however operations occur in wet-soil conditions, to remove mud and sand stuck to vehicles/machinery before they exist the site, it is suggested that stiff brushes and a high-pressure hose is used and that water is not mixed with a sterilant or chlorine solution given that it will drain directly into a bushland reserve area.

1. Where practical, schedule activities in dry-soil conditions to minimise clean-down effort and avoid the need for a wet-clean-down area.
2. If developing a temporary wet-clean-down area during operations at CL1 on Figure 2, ensure it is situated on a hard-stand area and all effluent is contained and directed into the existing open drainage adjacent to CL1. This will avoid water ponding where vehicle movements exit the site. Any drainage modifications in this area should be re-instated post construction or managed as agreed with the City of Busselton.
3. Include relevant dieback management measures in project contractual documentation and site induction materials.
4. Induct site personnel and any service providers on their dieback management obligations prior to their commencement of work on site.

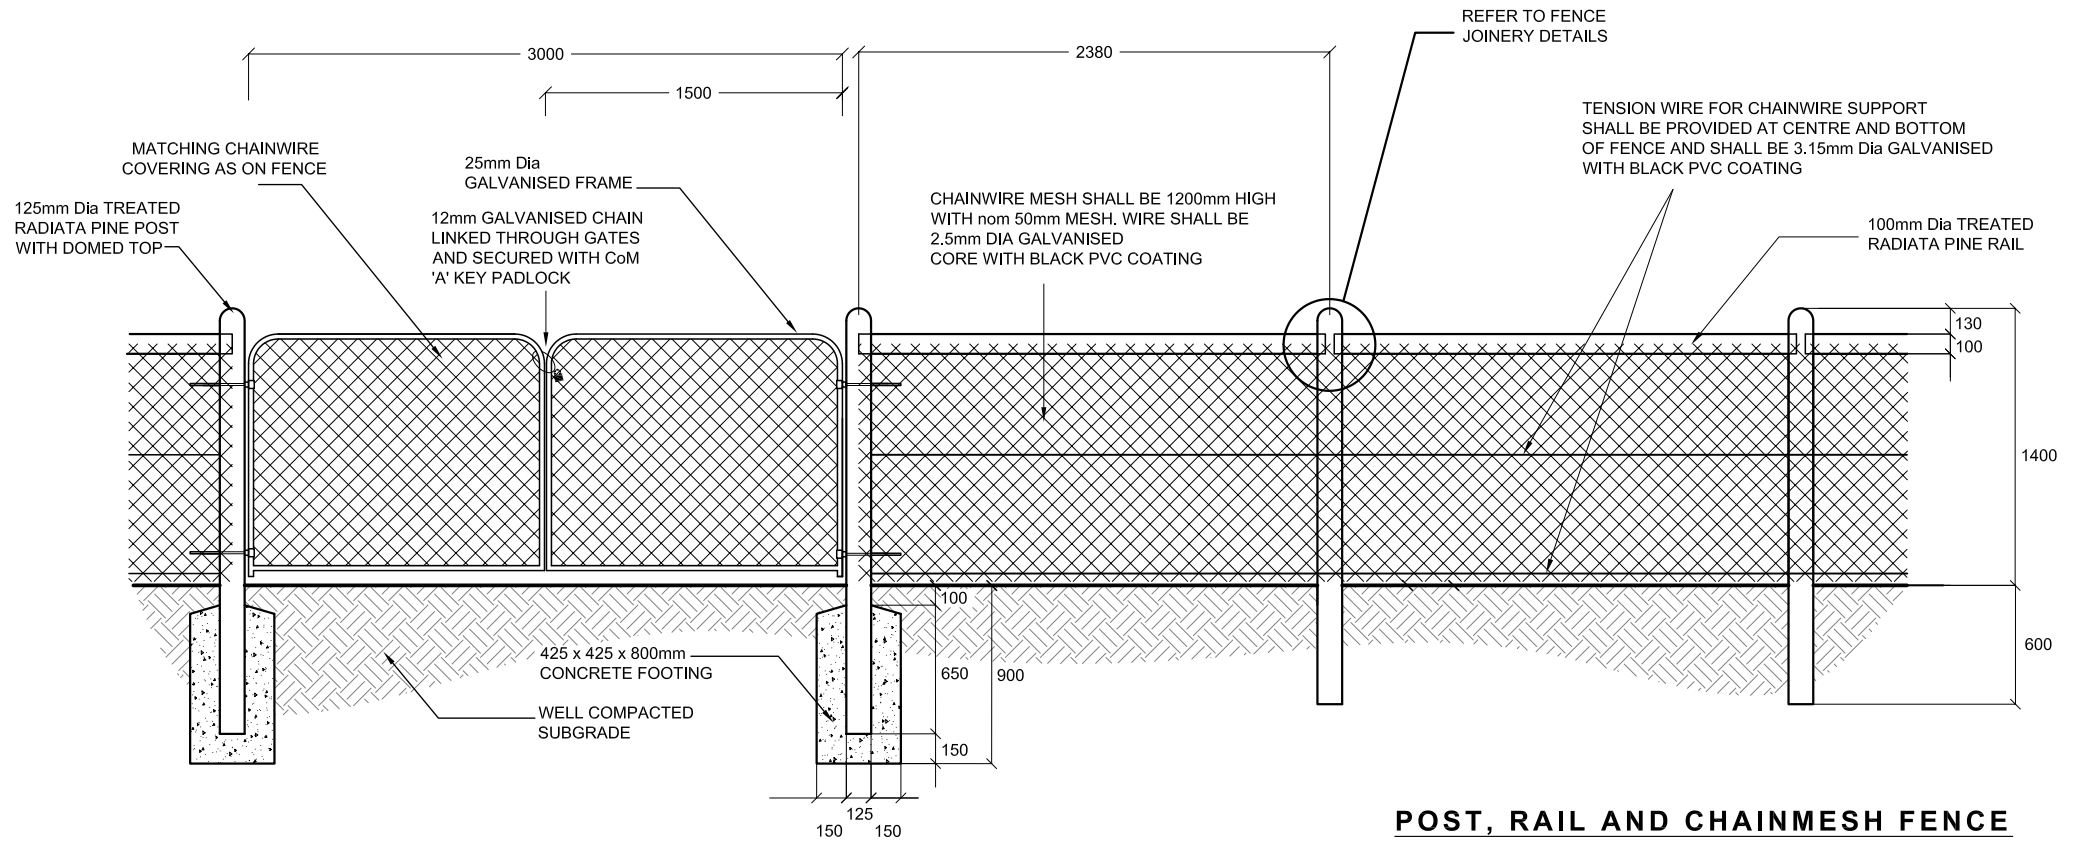
**POST, RAIL AND CHAINMESH FENCE**  
ELEVATION SCALE 1:40

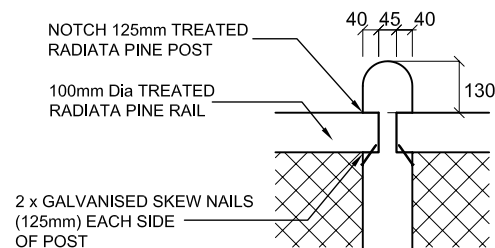
**FENCE JOINERY DETAIL**  
BACK SECTION SCALE 1:20

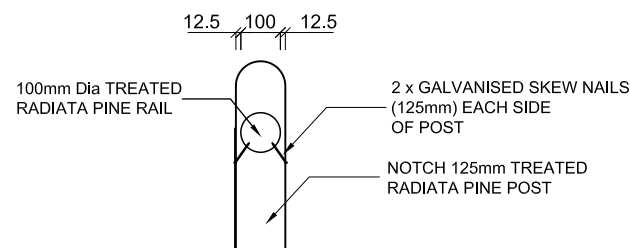
**FENCE JOINERY DETAIL**  
SIDE SECTION SCALE 1:20

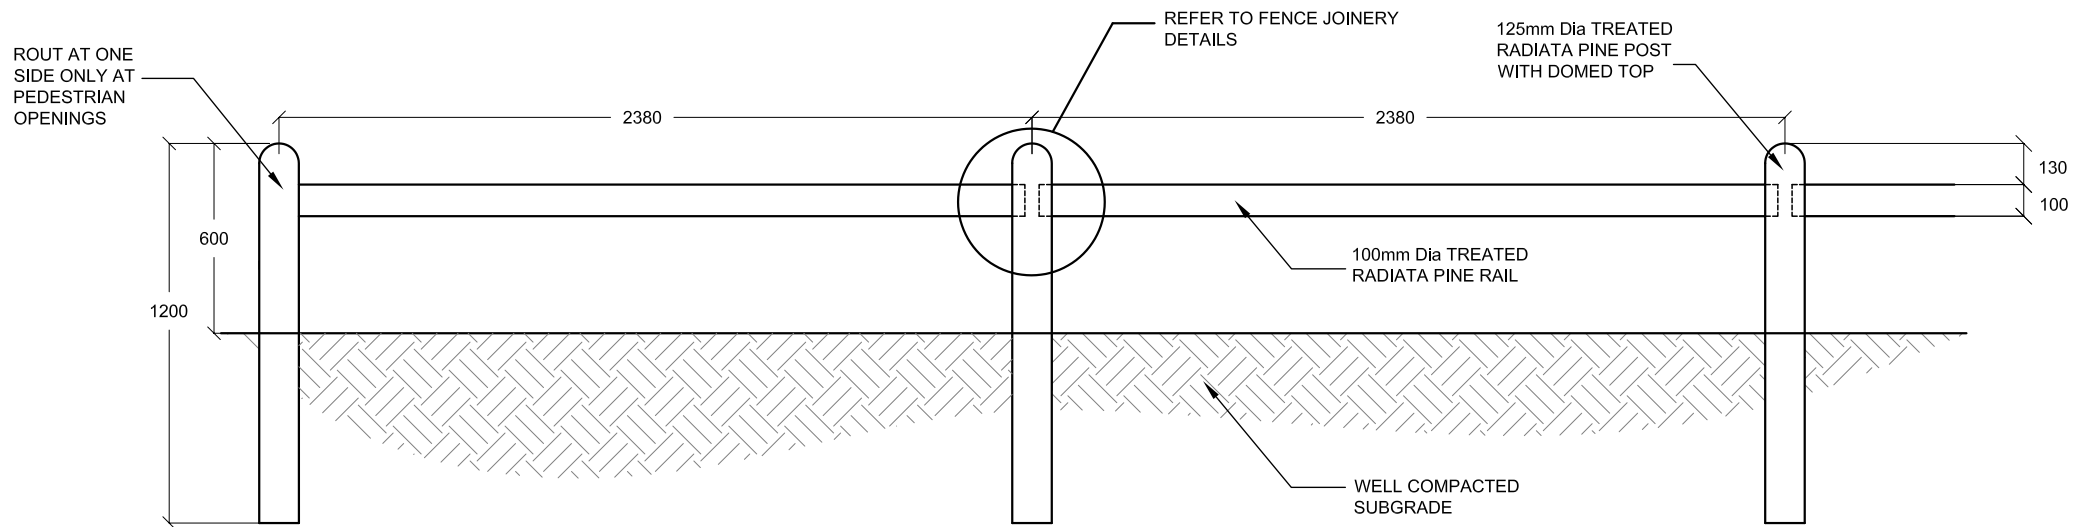
**POST AND RAIL FENCE**  
SCALE 1:25

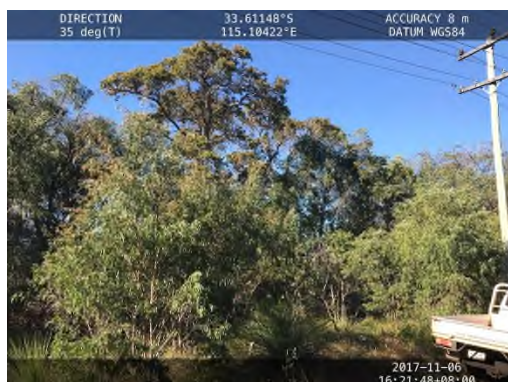
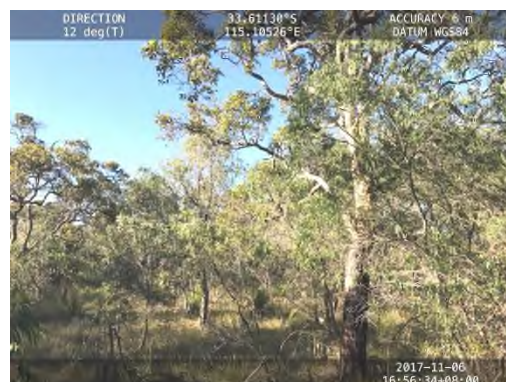
Photo ID: 1a

**Classification Applied:** Class A Forest

**Classification Justification:** Mixed Coastal Eucalypt Species, dense canopy (>70%) with grass and scrub under/middle story (Onsite)

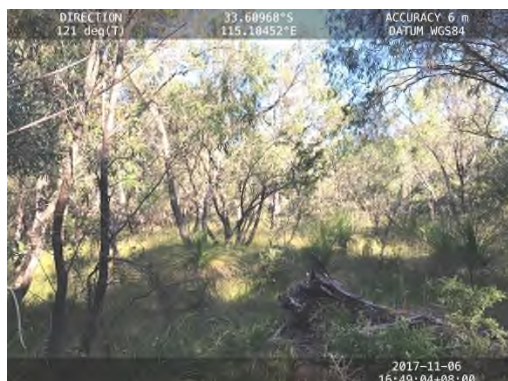
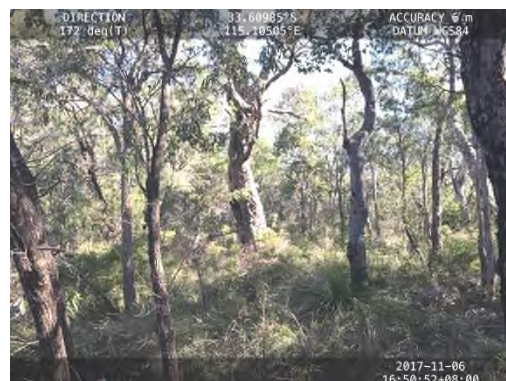
Photo ID: 2a

**Classification Applied:** Class A Forest

**Classification Justification:** Eucalypts & Peppermint, dense canopy with grass and scrub under/middle story (Offsite)

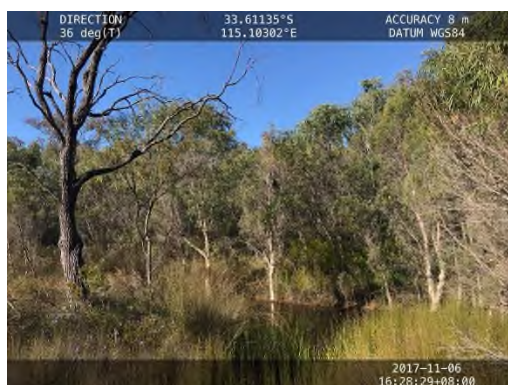
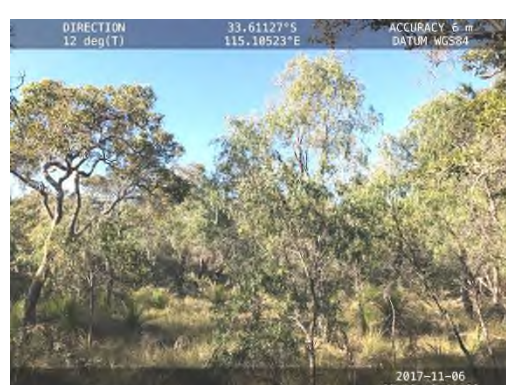
Photo ID: 3a

**Classification Applied:** Class A Forest

**Classification Justification:** Paperbark & Peppermint, dense canopy, scrub under story (Offsite)

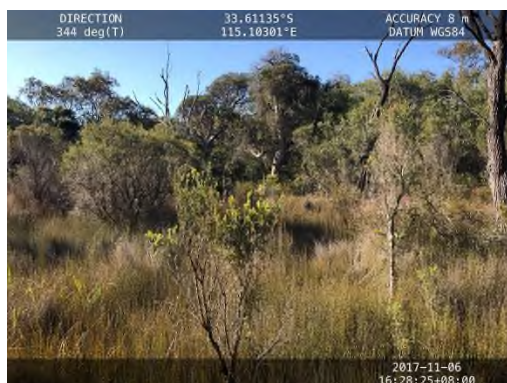
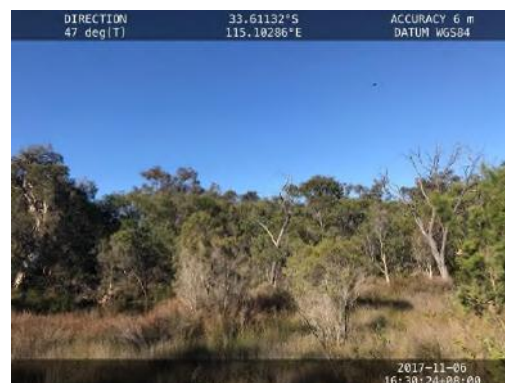
Photo ID: 4a

**Classification Applied:** Class A Forest

**Classification Justification:** Coastal Scrub/ Wetland and Forest Area (Forest in Background)

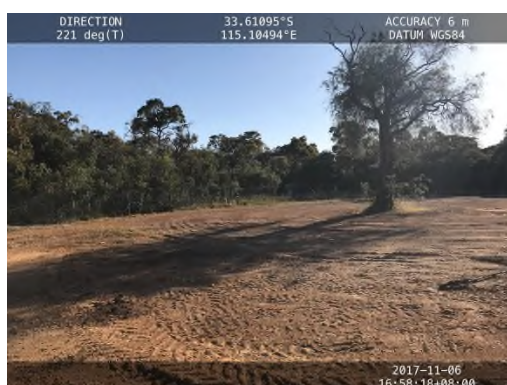
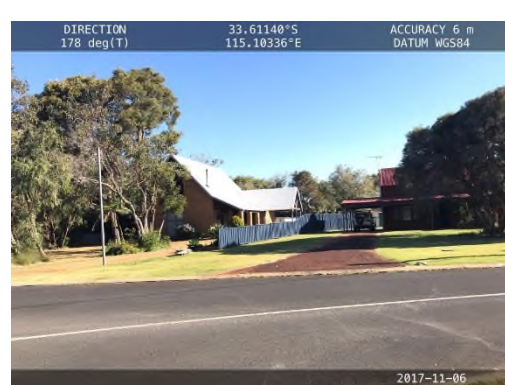
Photo ID: 5a

**Classification Applied:** Excluded AS3959-2009 2.2.3.2 (e)(f)

**Classification Justification:** Excluded – Low threat vegetation and non-vegetated areas (Residential Area)

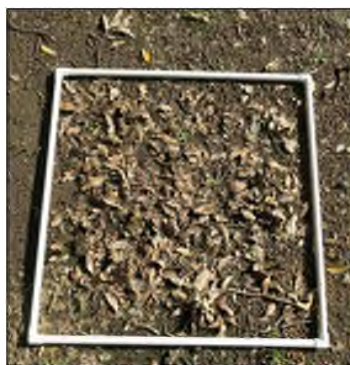
### Example Fine Fuel Load of Two Tonnes per Hectare

**Fine Fuel Load:** combustible dead vegetation matter less than 6 mm in thickness reduced to and maintained at an average of two tonnes per hectare (example below).

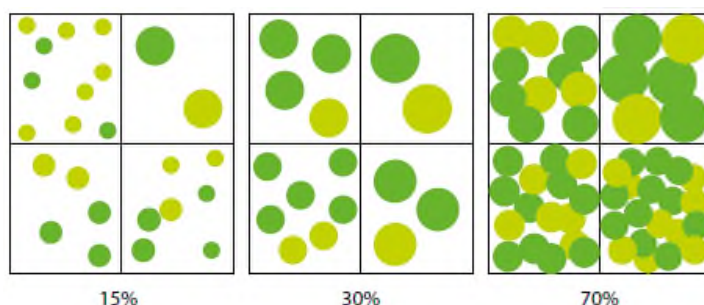
**Trees (> 5 metres in height):** trunks at maturity should be a minimum distance of 6 metres from all elevations of the building, branches at maturity should not touch or overhang the building, lower branches should be removed to a height of 2 metres above the ground and or surface vegetation, canopy cover should be less than 15% with tree canopies at maturity well spread to at least 5 metres apart as to not form a continuous canopy. Diagram below represents tree canopy cover at maturity.

*Tree canopy cover – ranging from 15 to 70 per cent at maturity*

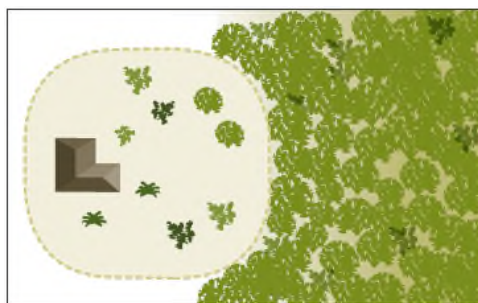
Hazard on one side  
APZ

The following example diagrams illustrate how the required dimensions of the APZ will be determined by the type and location of the vegetation.
